# Former Inwards Parcels Office Historical Archaeological Assessment and Research Design

Prepared by AMBS Ecology & Heritage  
for Urbis Pty Ltd

November 2021

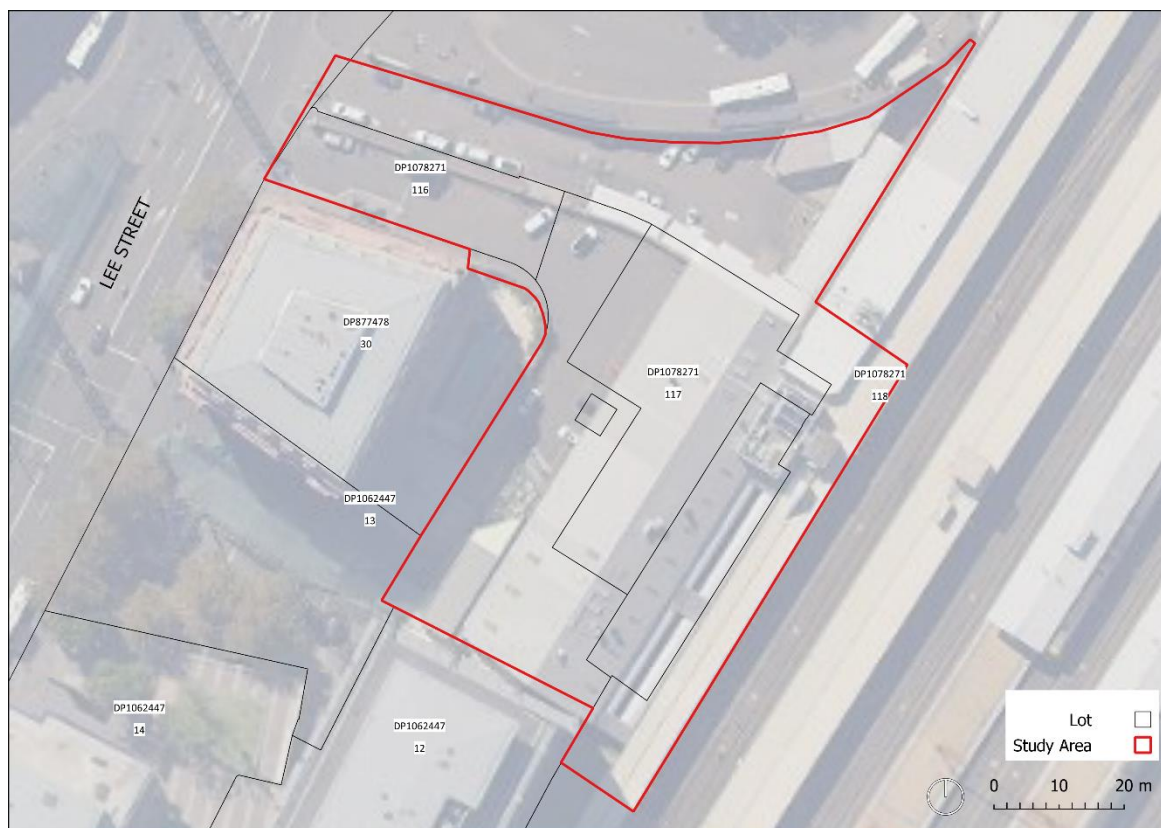
**Figure 1.1 Site location and boundary.**

SSD 10405 refers to the site at 8-10 Lee Street Haymarket, Lots 116, 117 and 118 in DP 1078271 and Lot 13 in DP 10662447. The site is known as 8-10 Lee Street, Haymarket. It is an irregular shaped allotment with a small street frontage to Lee Street; however, this frontage is limited to the width of the upper access road and that of Ambulance Avenue.

The Site has an area of approximately 3,764sqm which includes 277sqm of air rights that apply from RL40.

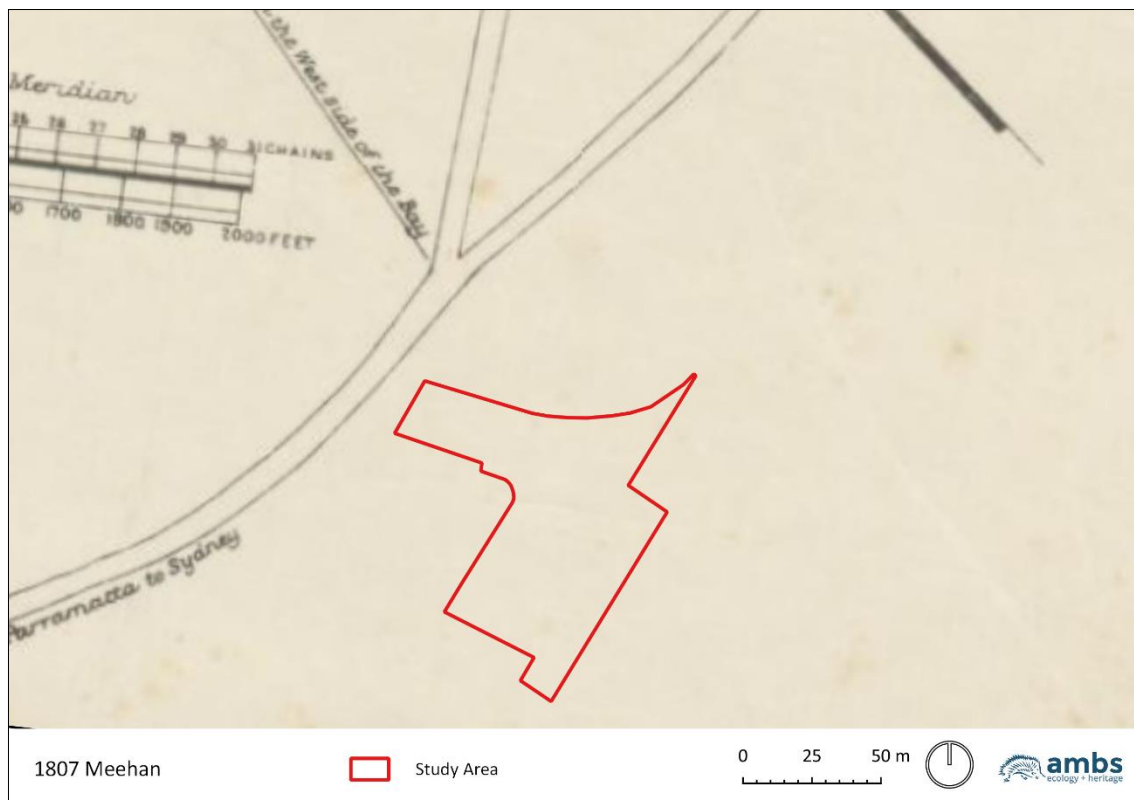
**Figure 3.1 1807 Plan of the town of Sydney in New South Wales, by Jas. Meehan, assistant surveyor of Lands, approximate location of Site indicated (Source: National Library of Australia).**

In the early days of the colony, the Site was in the outskirts of the city, the eastern portion of Sydney developed as the administration centre while the western portion was developed by the convicts, sailors and soldiers; however, there was little order to the development. The area surrounding the site of Central Station appears undeveloped in the 1807 Plan of Sydney; however, the area immediately to the north was the location of the brickfields (Figure 3.1).

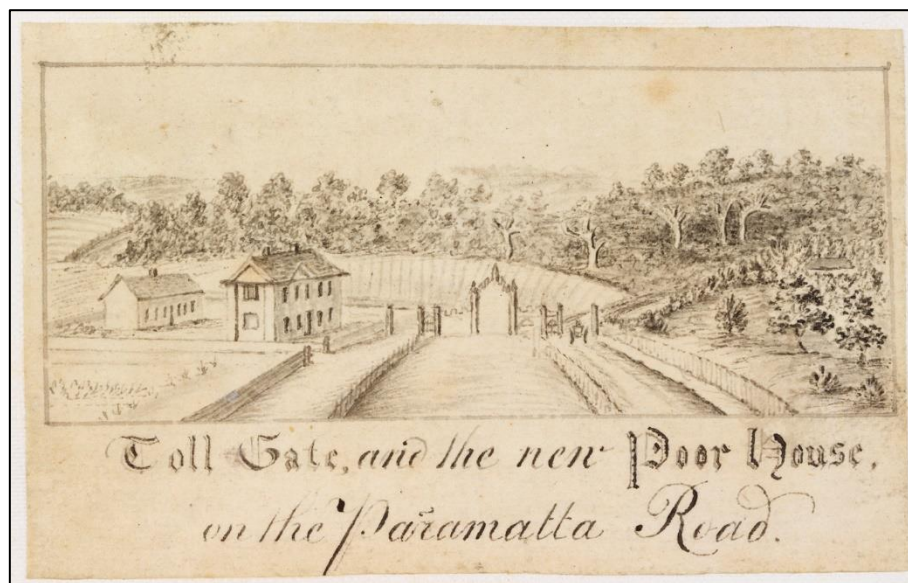
**Figure 3.2 Sketch of the Benevolent Asylum and Toll Gate pre 1830. The Main Building is to the right with the Kitchen and Superintendent's Building behind (Source: State Library of NSW, IE1130728, Views of Sydney and Surrounding District).**

The main building of the Asylum was a pseudo-classical, two-storey brick building that measured ninety-seven feet long and twenty-five feet wide; it faced Pitt Street and included a central staircase separating the men's dining room from the women's accommodation on the ground floor and providing access to the men's accommodation above (Rathbone, 1994: 22). A smaller building was situated behind the main building which housed the kitchen and Superintendent with a separate outhouse (Figure 3.2) (Annable, 2009: 20; Thorp, 1998: 12).

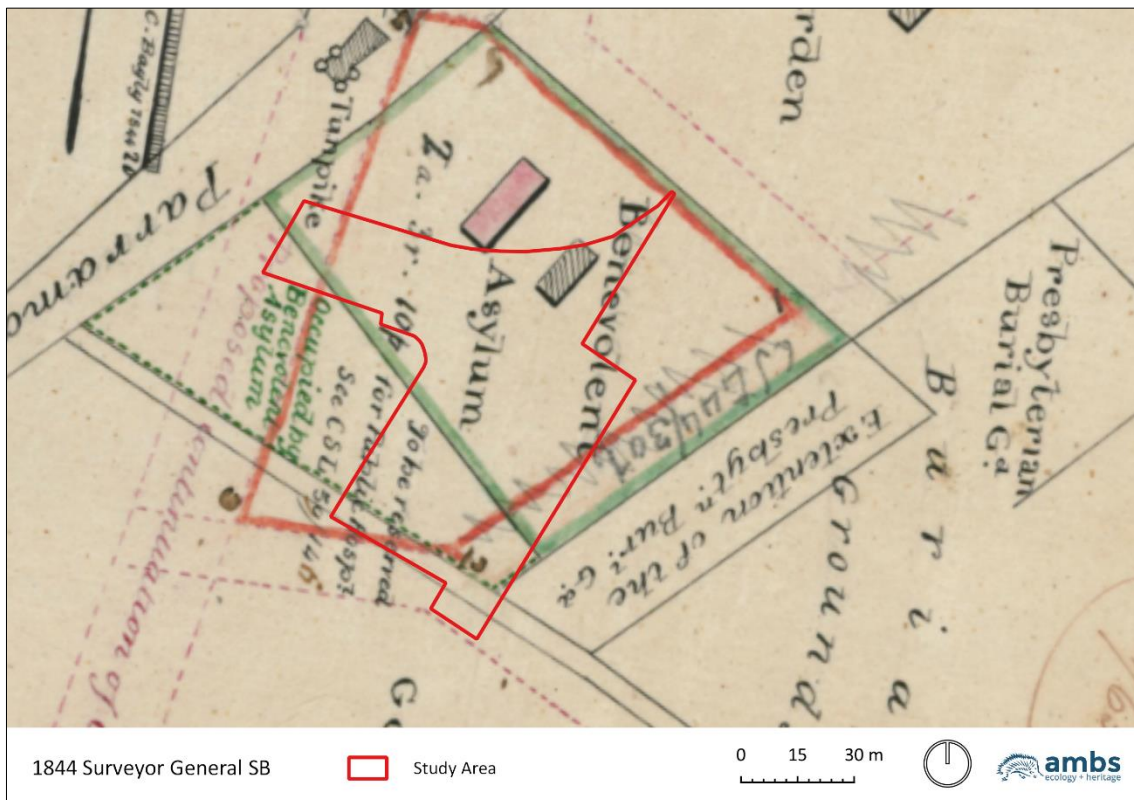
Figure 3.4 'Tracing Showing the Benevolent Asylum', Surveyor General Sketch Book 5 Folio 2 dated 1844 (approximate location of Site overlaid) (Source: State Library of NSW, IE195860).

The 1830s saw a number of additions constructed as the Asylum exceeded its maximum capacity; by this time, the Asylum housed 144 inmates; this was more than double the number it was built to house (Figure 3.3 and Figure 3.4) (Rathbone, 1994: 28). In c.1830, a north wing was added by the society and in 1839 a south wing was built with government funding, providing hospital facilities and additional accommodation (Rathbone, 1994: 27). In 1839, the building was described as *one of the handsomest public edifices in Sydney.... in an airy and agreeable situation* and, with the extensions, allowed for the accommodation of 200 people (Thorp, 1998: 12). By the 1850s, additions were made to the east of the kitchen wing and the southern wing was further extended (Figure 3.5) (Annable, 2009: 20).

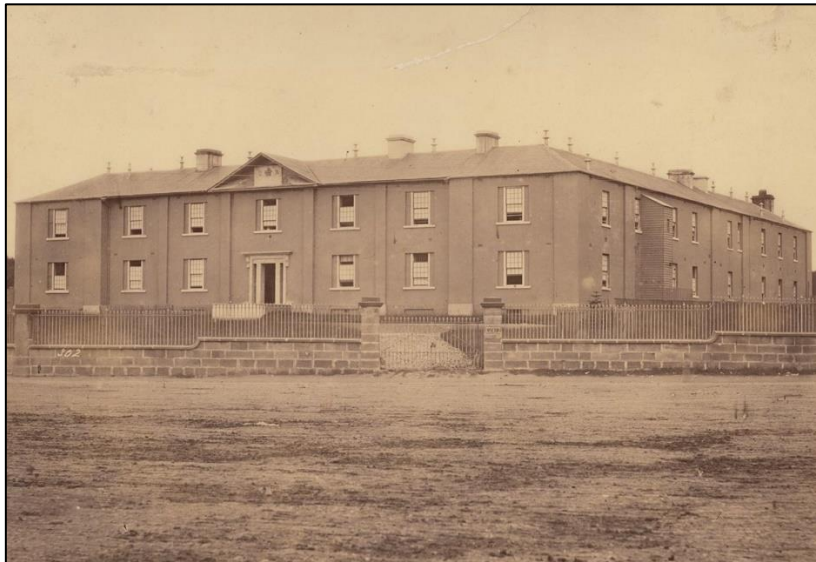
Figure 3.6 Benevolent Asylum 1871 (Source: State Library of NSW, IE1232164).

In 1874, the Benevolent Asylum was refurbished, including some minor alterations to the exterior, the removal of outbuildings, the replacement of the boundary fence and landscaping works to the front (demonstrated by a comparison of Figure 3.6 and Figure 3.7) (Thorp, 1998: 12). In c.1860s water was reticulated in the area and by the late 1870s it had been connected to the sewer (Figure 3.8) (Aird, 1961: 11; Henry, 1939: 157). The Benevolent Asylum continued operating, with no further alterations, until it was resumed for the construction of Central Station in 1901 (Figure 3.9).

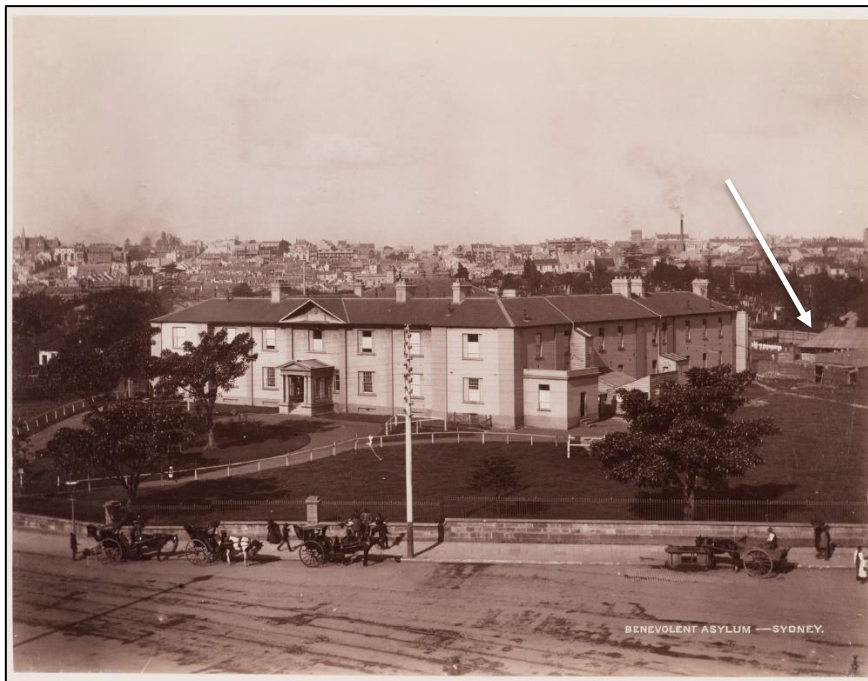
Figure 3.7 Benevolent Asylum c.1892-1900, note the additional buildings behind the southern wing which are likely the buildings coded iron in Figure 3.7 (Source: State Library of NSW, IE3326895).

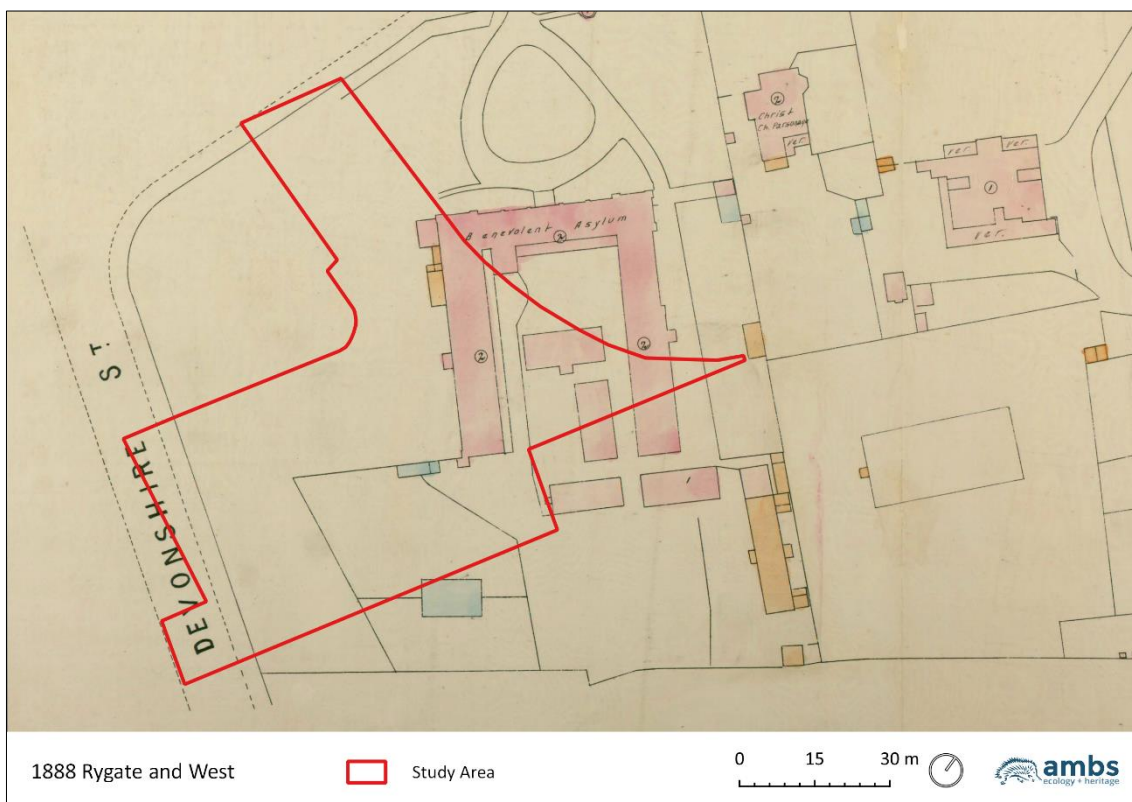
Figure 3.9 Rygate & West Plan of Sydney, Sheet 43, dated August 1888, showing the Site (approximate location overlaid). Note: The buildings referenced as iron (coloured blue), south east of the Benevolent Asylum, are likely the buildings seen in Figure 3.6 (Source: City of Sydney Archives, [A-00880458] <<https://archives.cityofsydney.nsw.gov.au/nodes/view/1709385>>).

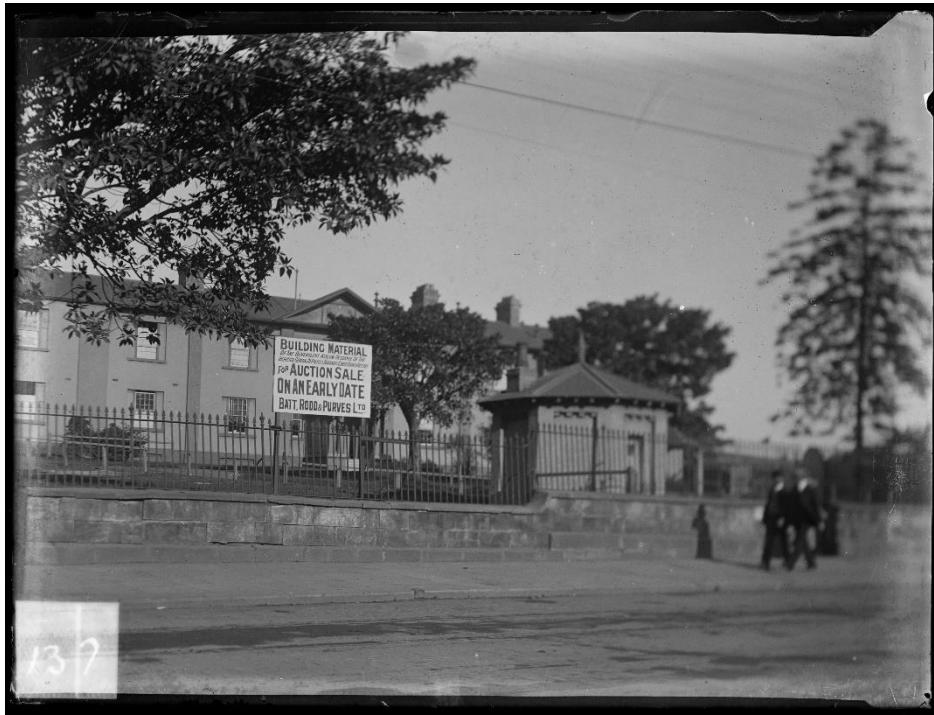
Figure 3.10 Benevolent Asylum on Pitt Street, sign for the auction of building material in forefront in preparation for the demolition and construction of Central Station. Note the slight uphill incline (Source: SL NSW, IE8546525, Glass Negatives of Sydney and Suburbs ca.1900-1914).

The land from the north of Devonshire Street to the south of Garden Road (now Eddy Avenue) and across to Elizabeth Street was resumed for the purposes of constructing Central Station in 1901. This included the demolition of all buildings within this area and the reinterment of the graves from within the cemetery. The buildings were demolished by day labour and the materials that were salvaged were sold (Figure 3.10, Figure 3.11 and Figure 3.12).

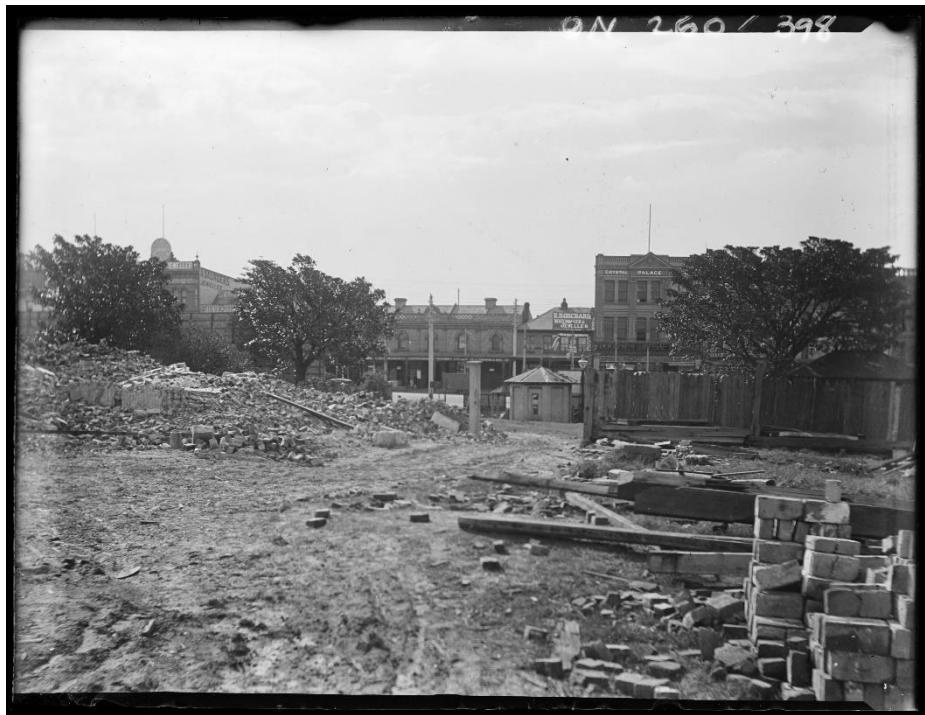
Figure 3.11 1901-1902 Benevolent Asylum after demolition, looking East towards Pitt Street (Source: State Library of NSW, IE8952327, Royal Australian Historical Society photonegatives).

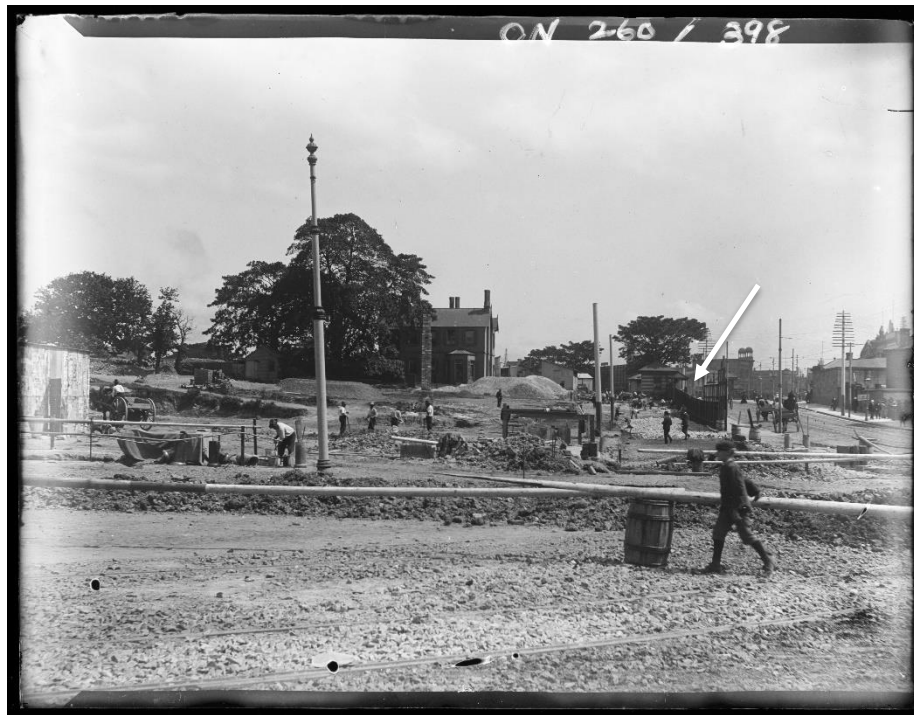
**Figure 3.12 1901-1902 demolition of the Benevolent Asylum, looking West from Pitt Street South. Note: some fence lines of the asylum have been arrowed (Source: State Library of NSW, IE8952327, Royal Australian Historical Society photonegatives).**

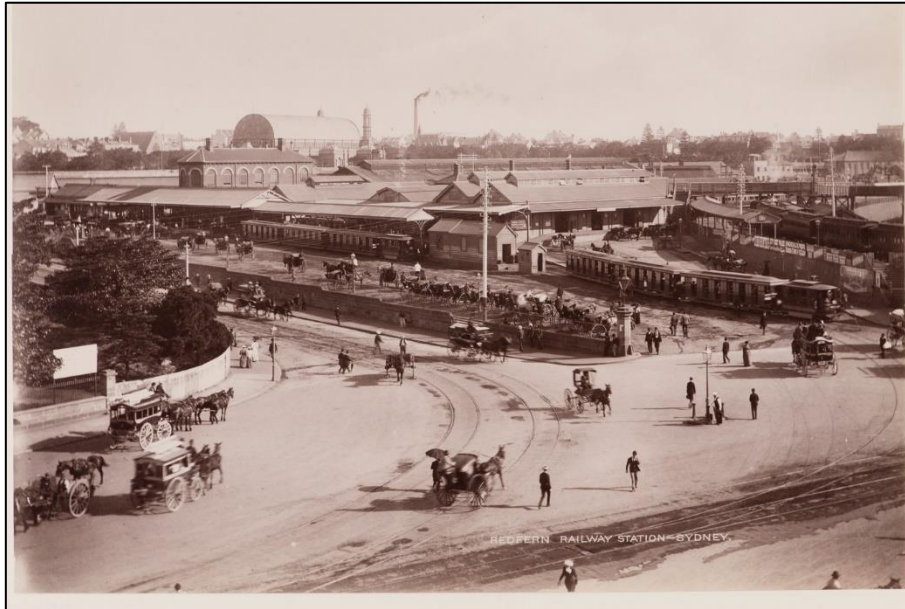
**Figure 3.17 Sydney's Second Station on Devonshire Street, ca.1882-1900 (Source; State Library of NSW, IE3326895).**

As a result of public pressure for a permanent station, a new station was built in the same location in 1871 and opened in 1874. The new station building was a neo-classical brick construction with two platforms. A third platform was constructed in 1878 to meet the demands of the increasing number of passengers (Thorpe, 1998: 17). Additional carriage sheds, good sheds, workshops, siding and other infrastructure were also constructed. The number of platforms were eventually increased to 13, with the original platforms becoming platforms five and six (Figure 3.17).

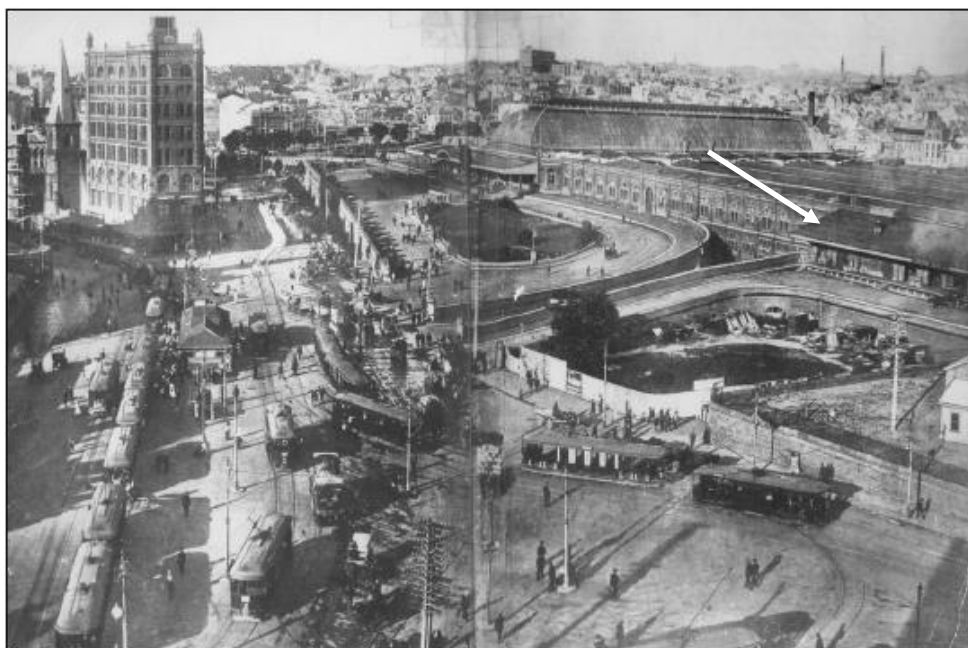
Figure 3.22 Central Station overlooking Railway Square, prior to 1913. Inwards Parcels Shed is seen to the right (Source: Weir Phillips Heritage & Planning 2018:15)

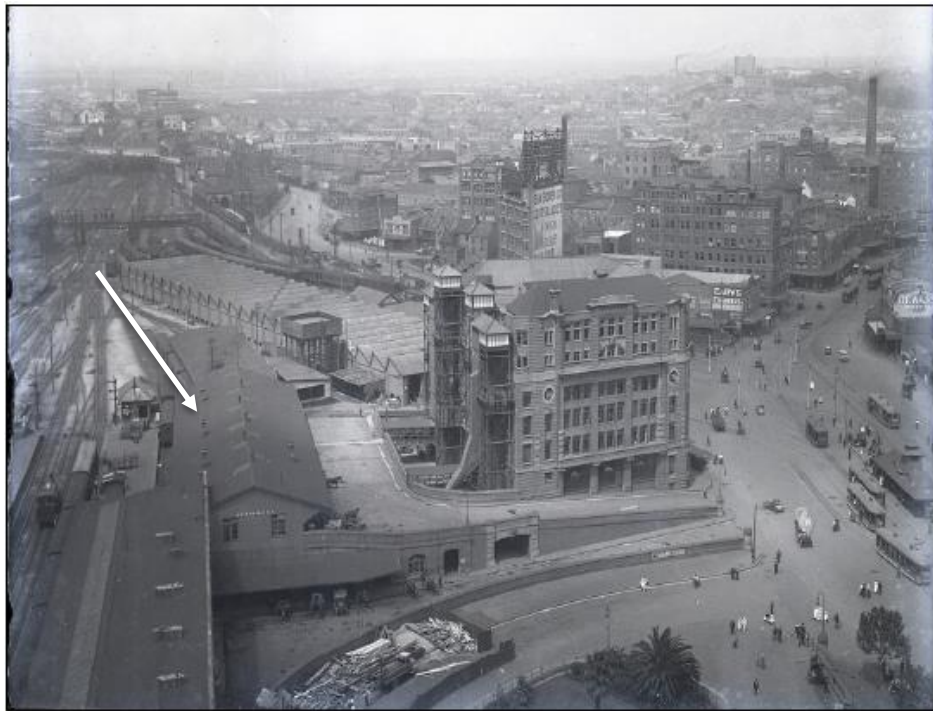
**Figure 3.23 Central Station looking south. Inwards Parcels Shed and Post Office, 1910s, with chutes attached to the Post Office (Source: Weir Phillips Heritage & Planning 2018:15).**

The Parcels Post Office was opened in c.1913 and was constructed adjacent to the Inwards Parcels Shed. The building was built of brick with stone dressings, it was originally four storeys and was extended to six (Thorp, 1998: 21). External parcel chutes were built onto the eastern façade which lead to the passageway under the Inwards Parcels Shed (Figure 3.23). These chutes were removed in the late twentieth century.

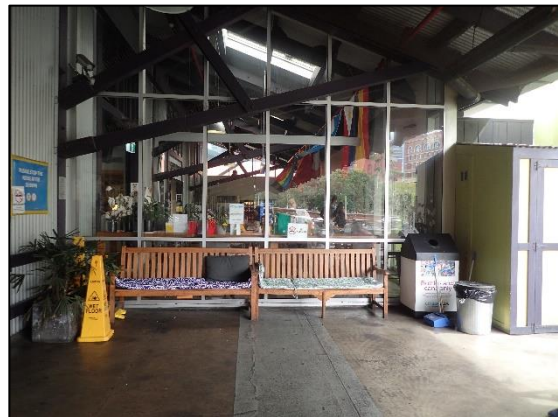
Figure 4.6 View south-west of windows into the dining area of the YHA, adjacent to the entrance (left).

The western elevation of the building contains the entrance (Figure 4.6). This entrance leads into the main reception and lobby area of the YHA atop a floating concrete floor (Figure 4.7). To the west of the reception desk is a dining room (Figure 4.8). There is a mezzanine level accessed via stairs in the lobby that lead to additional accommodation for the hostel (Figure 4.9). The lower level of accommodation within the building is accessed through a gated door north of the lobby (Figure 4.10 and Figure 4.11). A door on the eastern elevation of the building leads to additional exterior accommodation immediately adjacent to the CountryLink platforms of Central Station; a glass barrier separates the carriages from the platforms (Figure 4.12 to Figure 4.13). Four dormitories resembling railway carriages stand on a rail siding off the original Platform 1 of Central Station (Figure 4.14).

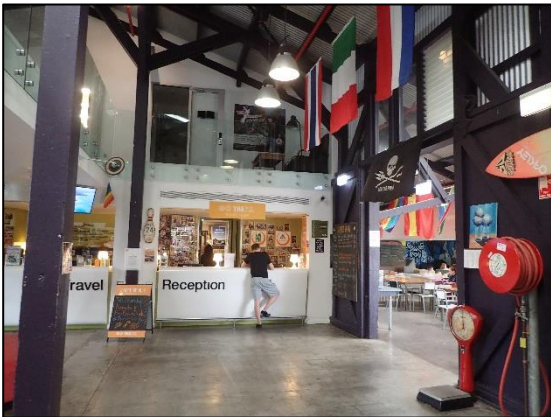
Figure 4.7 View south-west of the YHA reception area.

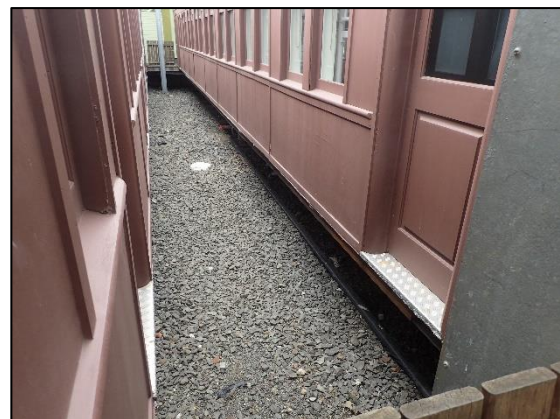
Figure 4.14 View north-east of carriages, showing former rail siding associated with Central Station.

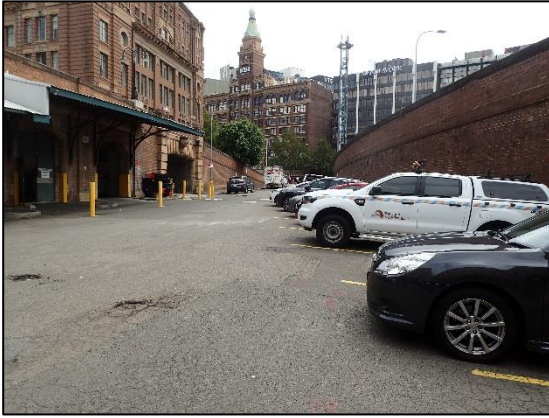
Figure 4.15 View west of Ambulance Avenue, towards Lee Street. The Adina Hotel is to the left.

Ambulance Avenue provides access to the 'basement' level beneath the YHA; it is situated between the curved brick retaining walls of the Western Forecourt of Central Station to the north, and the ramp from Lee Street to the south (Figure 4.15 to Figure 4.17). A corrugated metal awning attached to the retaining wall of the Lee Street ramp extends out over the basement level (Figure 4.18 and Figure 4.19). This lower level consists of concrete vaults, with masonry walls supporting the floor of the YHA above. These vaults function as workshop spaces associated with catering services for the CountryLink trains, as well as garbage disposal facilities and amenities (Figure 4.20 to Figure 4.30). There are various tunnels in this basement level, with one leading to Central Station and another to Henry Deane Plaza (Figure 4.22 and Figure 4.29).

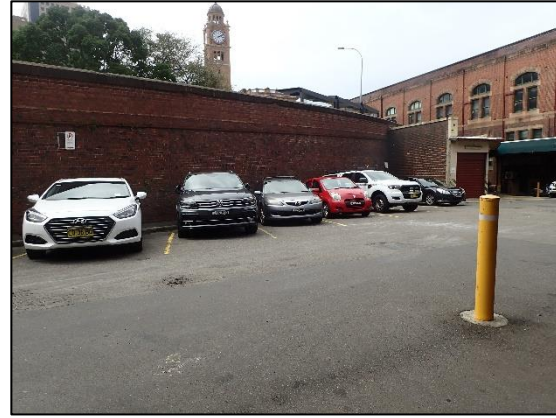
Figure 4.16 View north-east of retaining wall north of Ambulance Avenue. The Central Station clocktower is in background.

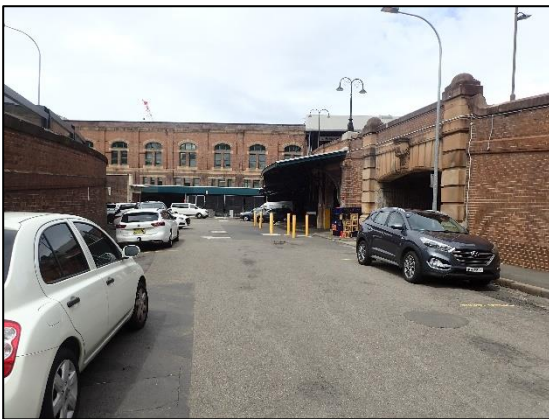
Figure 4.17 View east of Ambulance Avenue, from Lee Street, showing level beneath the YHA.

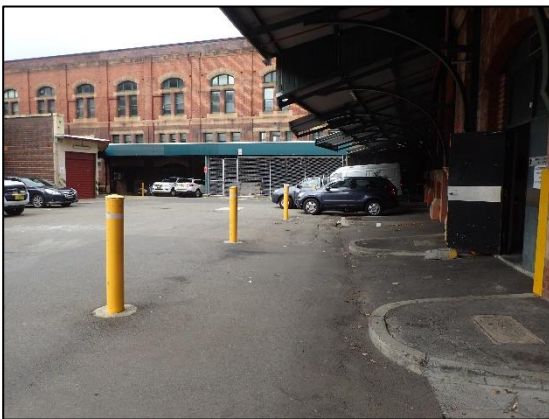
Figure 4.19 View south-east of Ambulance Avenue, showing the underside of awning over basement level.

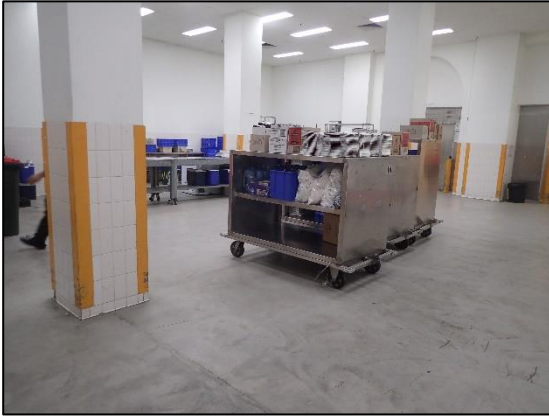
Figure 4.20 View south of room associated with CountryLink catering services beneath YHA.

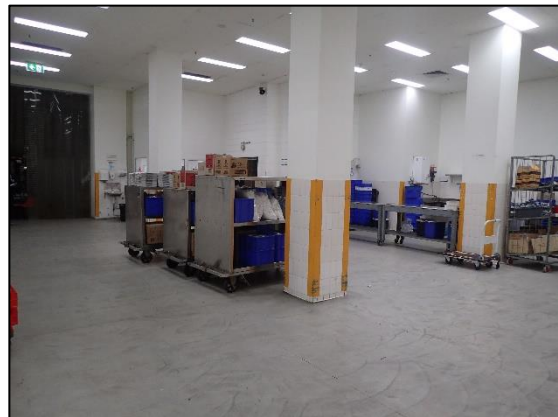
Figure 4.23 View south-west of room associated with CountryLink catering services beneath YHA.

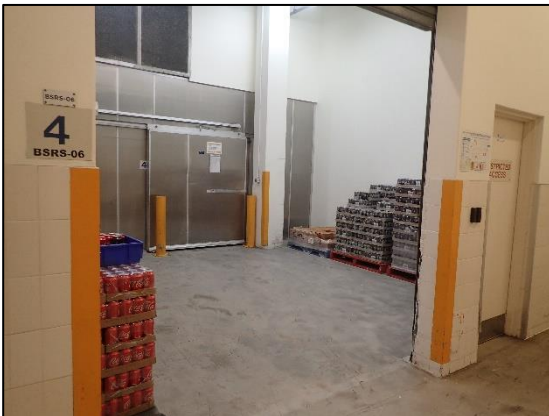
Figure 4.24 View north-east of room associated with CountryLink catering services beneath YHA.

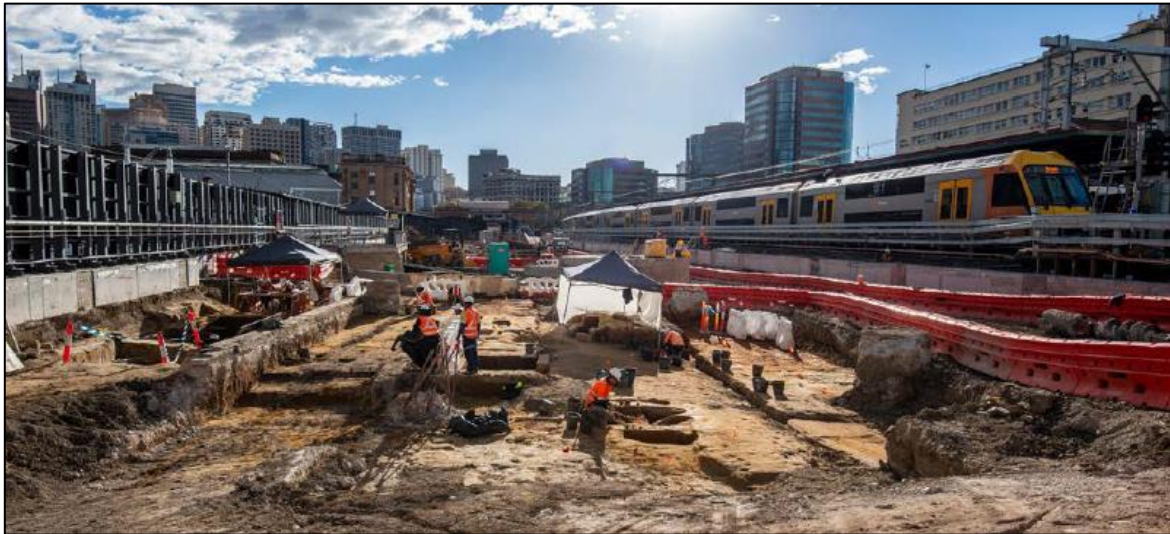
**Figure 5.3 View north of archaeological excavations at Central Station undertaken by Artefact Heritage (Sydney Metro, 2019: 2).**

Artefact Heritage began their archaeological works in 2019 (Figure 5.3). The post excavation reporting for this project is currently being undertaken; thus, the exact results are not yet available. A newsletter published by Sydney Metro in October 2019 identified that evidence of the original Central Station and Devonshire Street Cemetery had been excavated, stating that *artefacts*

including coins, rings and coffin fixtures have been identified as well as sandstone vaults, gravesites and fragments of human remains...over 70 grave sites and seven vaults have been uncovered (Sydney Metro, 2019: 2).

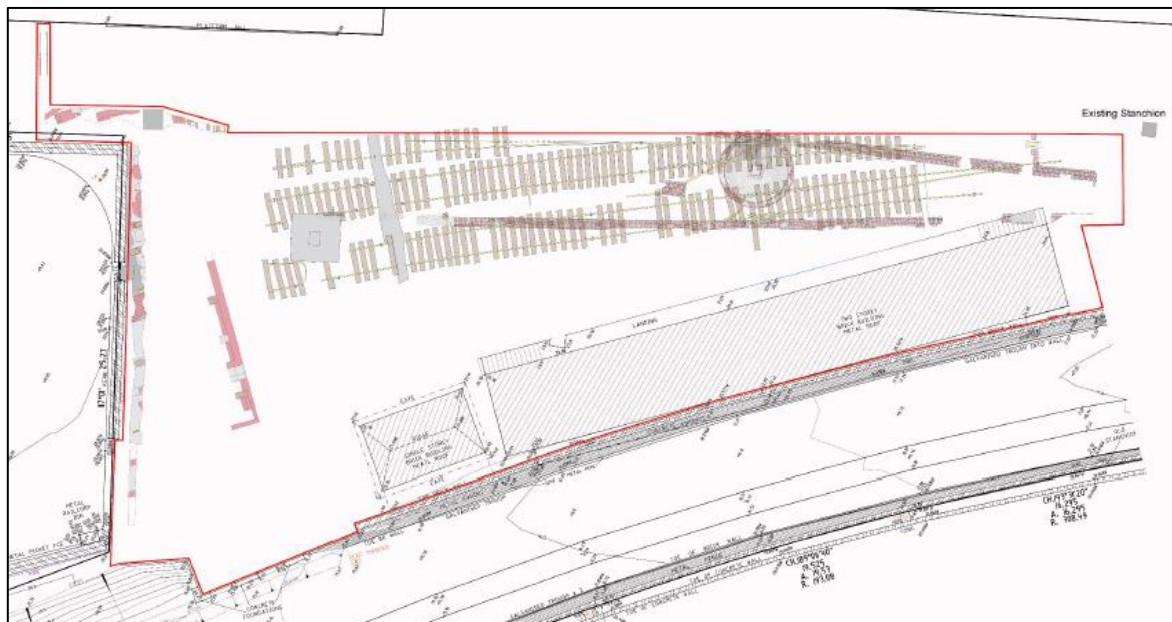
Figure 5.4 Detail of plan of archaeological findings at Lee Street Substation site 2016-2018 (area of excavation outlined in red). Areas shaded grey indicate concrete, orange indicates ceramic, pink represents brick, yellow indicates metal and brown indicates timber (AMAC, 2019: 63).

Archaeological monitoring and salvage excavation were undertaken by AMAC between September 2016 and June 2018, at the Lee Street Substation site, in the Western Precinct of Central Station. The site required a combination of monitoring and targeted and open-area excavation (AMAC, 2019: 61). State significant archaeological remains were uncovered during archaeological monitoring along the eastern flank of the site from September to November 2016, including several sandstock brick footings and remains of a wagon turntable foundation [073] (AMAC, 2016: 61-62). The discovery of these substantial remains prompted an *Archaeological Assessment & Research Design* to be prepared as supporting documentation for an additional excavation permit under s60 (AMAC, 2019: 61). Remains from the first, second and third Sydney Station phases were uncovered at the site (Figure 5.4).

The removal of footing [080] revealed a sand, gravel and redeposited clay backfill. Beneath this backfill was a circular sandstock brick footing [073], belonging to the first Sydney Station phase (c.1870). The foundation was for a wagon turntable, functioning as a mechanism to move rail vehicles from one track to another (AMAC, 2016: 96). It was 4.63m in diameter and was comprised

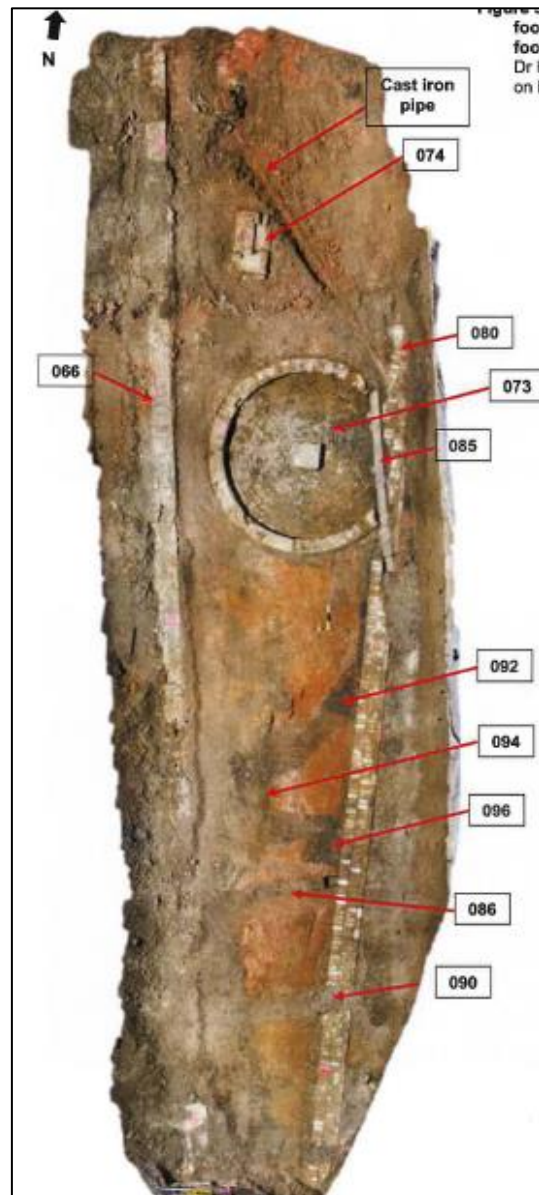
Figure 5.5 Orthographic photo of the linear brick footings [066 and 080] as well as turntable footing [073] (AMAC, 2016: 84).

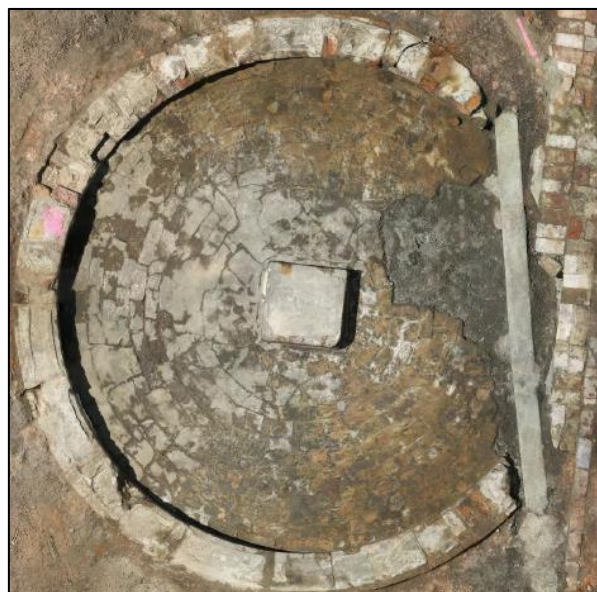
Figure 5.6 Detail of wagon turntable footing [073], facing north-east (AMAC, 2019: 125).

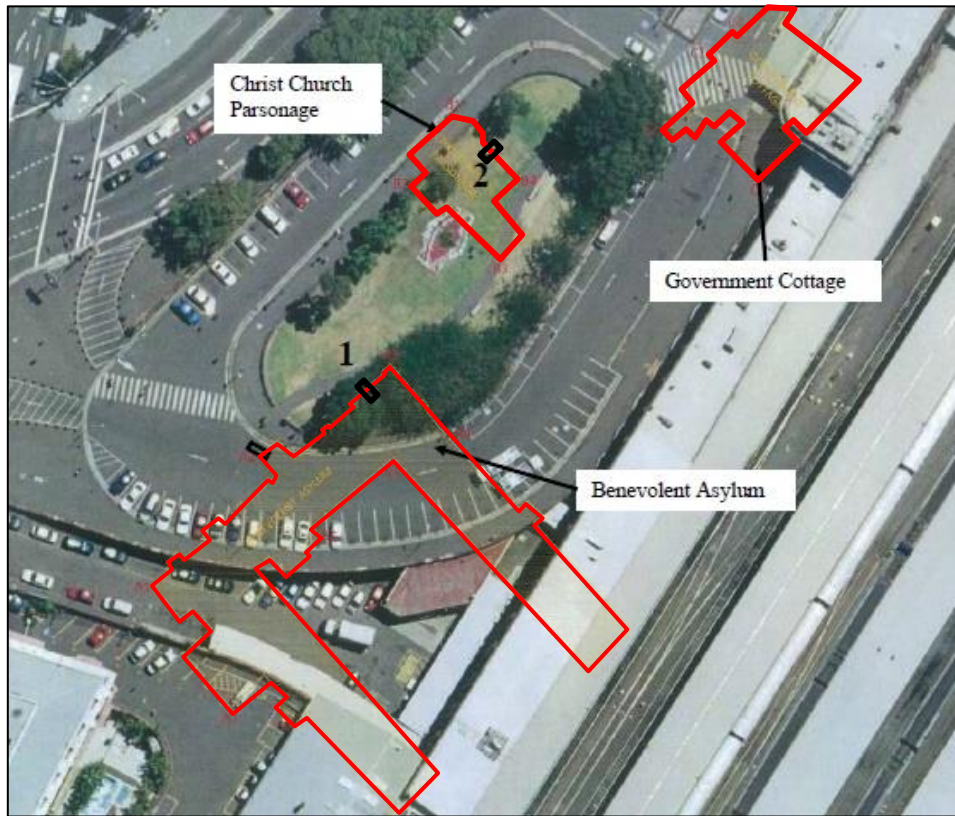
Figure 5.7 Plan of the Western Forecourt, with an overlay of former historic structures of the Benevolent Asylum and Christ Church parsonage. Due to the poor visibility of the structures in the overlay, they have been outlined in red. The locations of Trench 1 and 2 are also indicated (Casey & Lowe, 2009: 1).

This archaeological investigation, particularly of Trench 1, is significant to the understanding of the archaeological potential of the Site. It demonstrates that foundation trenches associated with the Benevolent Asylum and evidence of its demolition may also be uncovered within the Site. The relationship between the findings of Casey & Lowe, and the disturbance and alteration of the nineteenth century landscape has been explored in further detail later in the report.

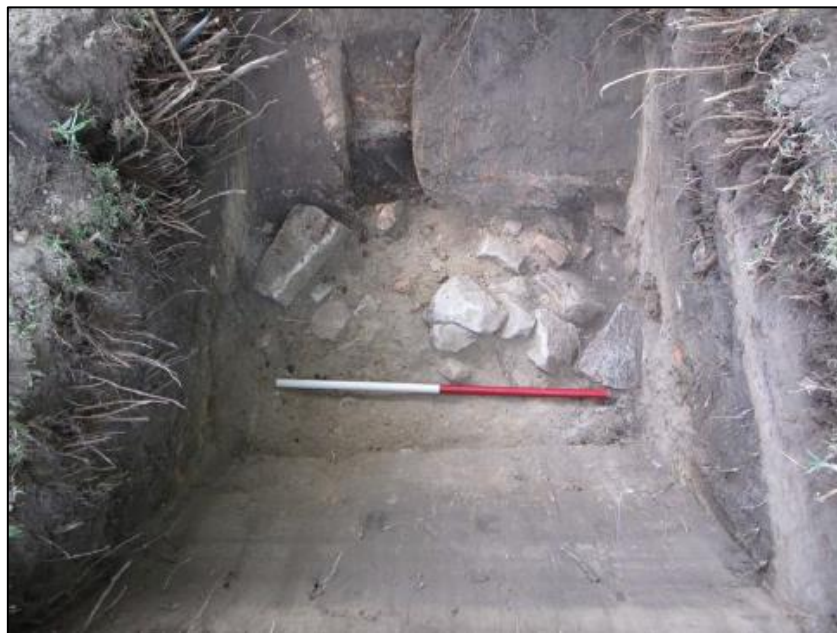
Figure 5.8 Northern end of Trench 1 showing stone rubble interpreted as remains of Benevolent Asylum wall (Casey & Lowe, 2009: 8).

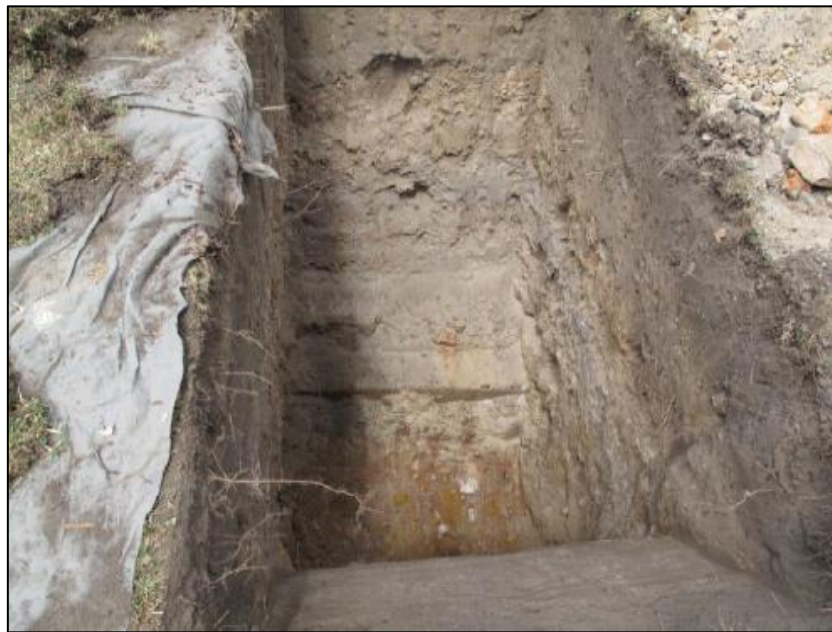
Figure 5.9 Sandstone footing at the base of Trench 2 (Casey & Lowe, 2009: 11).

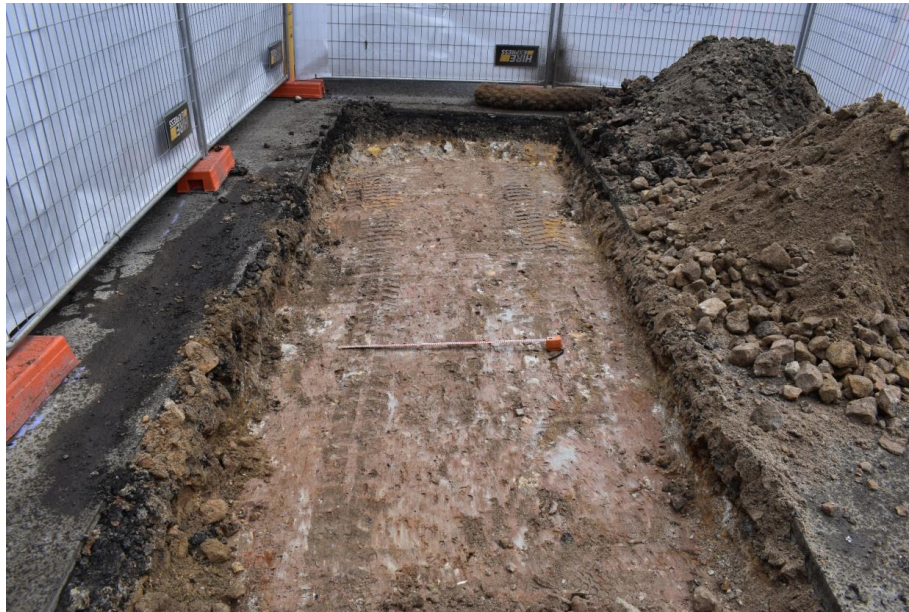
**Figure 5.11: Exposed natural clay beneath the road base in Trench 1 (Artefact Heritage 2021).**

The surface of Test Trench 1 (RL 15.1m) consisted of the asphalt road surface and underlying road base, which continued to a depth of about 160mm. The asphalt and road base were founded on a layer of crushed sandstone which was present across the entire trench. The layer of crushed sandstone was about 160mm deep and covered mottled red-white sterile clay (Figure 5.11). A 1000mm x 500mm x 200mm sondage was excavated along the northern side of the trench to confirm that the clay was the natural subsoil. Excavations in Test Trench 1 therefore ceased at a depth of 320mm (RL 14.78) where the natural clay was identified.

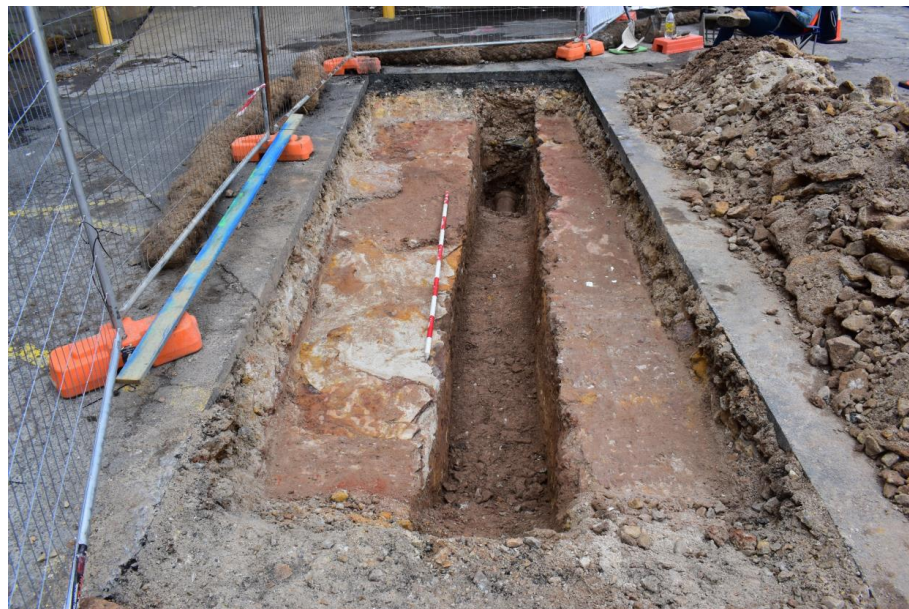
**Figure 5.12: Service cut through the bedrock in Trench 2 (Artefact Heritage 2021).**

The surface of Test Trench 2 (RL 14.87) consisted of the asphalt road surface and underlying road base, which continued to a depth of about 160mm as it did in Test Trench 1. The removal of the road surface identified the same deposit of crushed sandstone found in Test Trench 1. The crushed sandstone was again about 160mm deep and covered the natural red-white sterile clay (RL 14.55). The clay was between 80-160mm deep and covered the sandstone bedrock (RL 14.45).

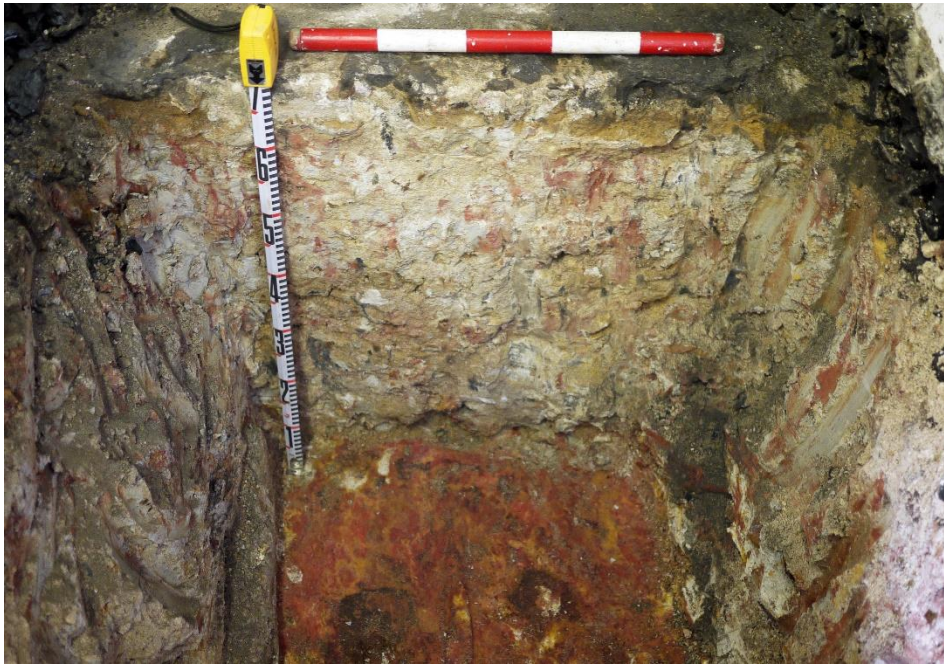
Figure 5.14: South-facing section within TP4.8 showing iron stained bedrock at the base.

Depth below surface	Description	Interpretation
0mm-180mm	Thin slab and loose metalling, bitumen	Construction base and surface
180mm-650mm	Pale light grey clays, strong pedal structure, laminations of iron oxide between peds	Unaltered soil unit. Very similar to Blacktown soil landscape unit bt4. Indicates several upper units have been removed from the site.
650mm-875mm	Degraded fragments of sandstone stained heavily with iron in strong pedal clay matrix. Iron becoming more prevalent	
875mm	Sandstone bedrock with heavily weathered surface, stained with red iron oxide; splits along shallow horizontal planes with moderate applied force

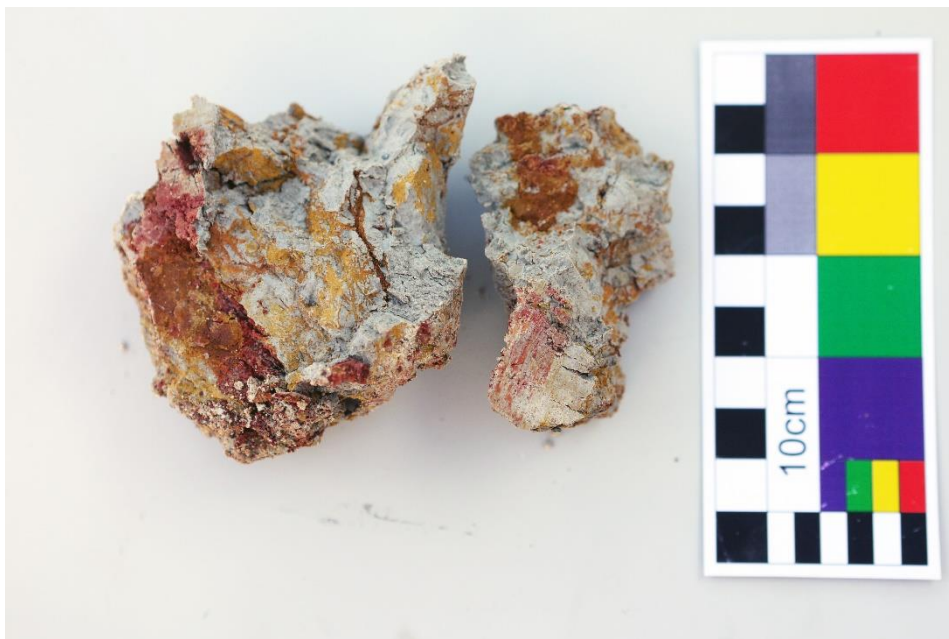
Figure 5.15: Clay sample from TP4.8 showing strong pedal structure and iron laminations. This material is consistent with an in situ unit and strongly resembles Blacktown soil landscape unit bt4.

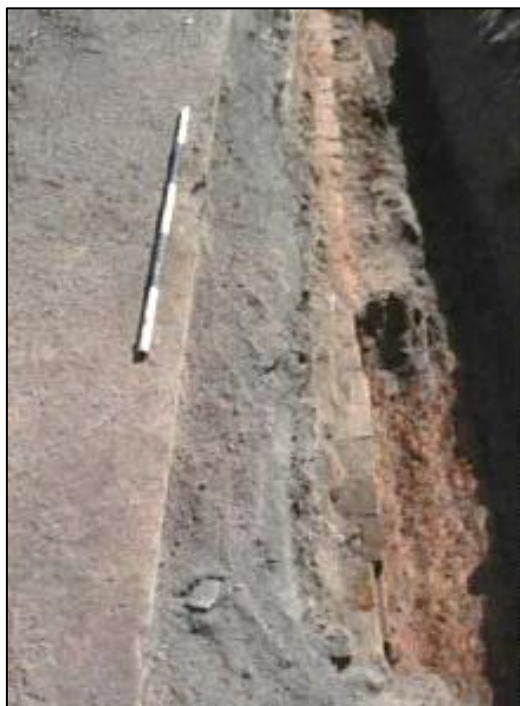
**Figure 5.17 View north of convict-built box drain (GML, 2009: 40).**

The Site was first developed in c.1810-1813, when a brick hospital was constructed. From 1822-1829, a larger second hospital was constructed north of the original hospital; the Georgian brick and sandstone structure was built by convict labour (GML, 2009: 12). The earliest archaeological evidence exposed during investigations was a convict built sandstock brick box drain associated with the first hospital phase of the site. The box drain was uncovered in the concrete entrance driveway adjacent to the main building; it ran north-south and had no bonding (Figure 5.17). The investigations of this drain allowed for a better understanding of the location of the first hospital; it was situated further north than originally presumed. As such, it was stated that there was high potential for archaeological remains of the hospital to exist in the area between the driveway and the south wing of the main building (GML, 2009: 41). The fire hydrant service was laid further east to avoid impacts to the drain (GML, 2009: 45).
