# Former Inwards Parcels Office Historical Archaeological Assessment and Research Design

Prepared by AMBS Ecology & Heritage  
for Urbis Pty Ltd

November 2021

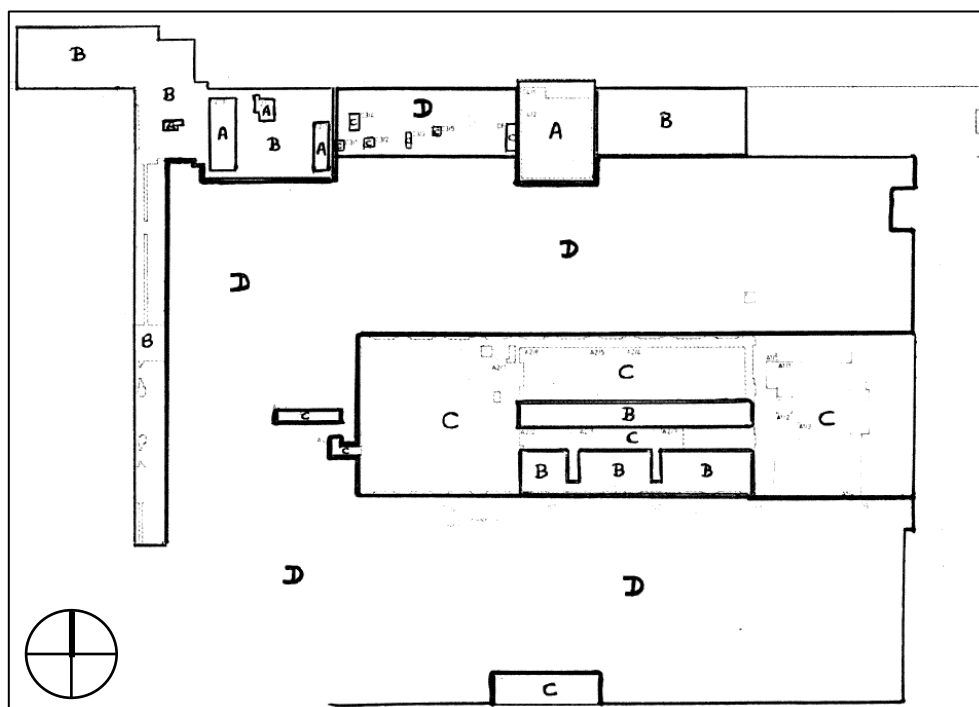
Figure 5.20 Archaeological zoning plan of Levels 2 & 3 of the Hyde Park Barracks site following excavations in 1980-81. Areas labelled A are those that should not be disturbed, those labelled B should be investigated prior to proposed disturbances, those labelled C refer to disturbed or thoroughly investigated areas where no further archaeological work is required and D refers to the need for archaeological supervision of disturbances.

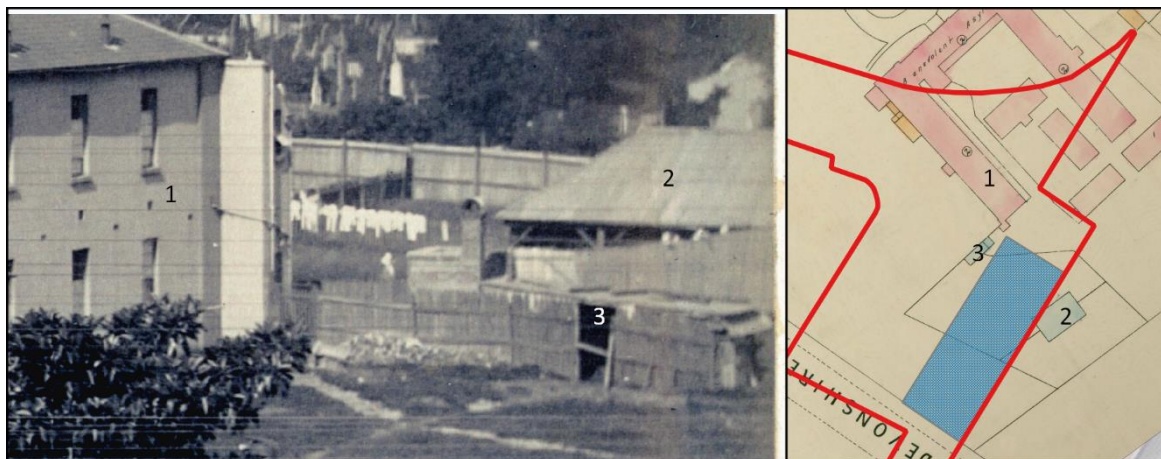
Figure 5.25: The area of Moderate potential (blue) is located outside the footprint of known structures. On the left is a detail from an 1892-1900 photograph of the asylum (State Library of NSW, IE3326895), and on the right is a detail of Rygate and West's 1888 plan showing the same structures.
